EQUINE PROTECTION NETWORK

Diagram of 50' trailer designed to transport horses.

Diagram of 50' double decker trailer used to transport horses.

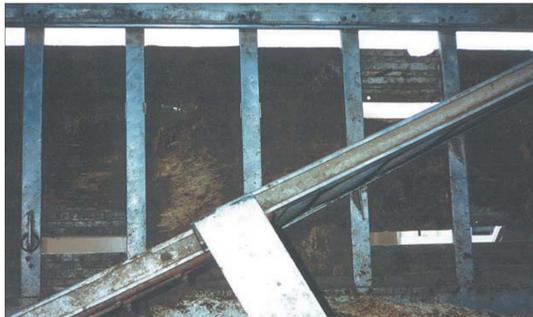
■ Interior view of bottom deck of double decker trailer. Besides the 3" I beams protruding below the ceiling, there is a ramp that is stored on the ceiling.

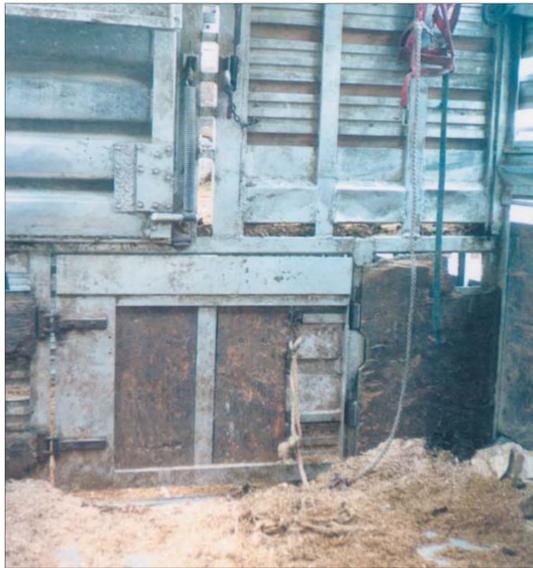
■ Ramp located in "dog house" area used to load horses to the top deck.

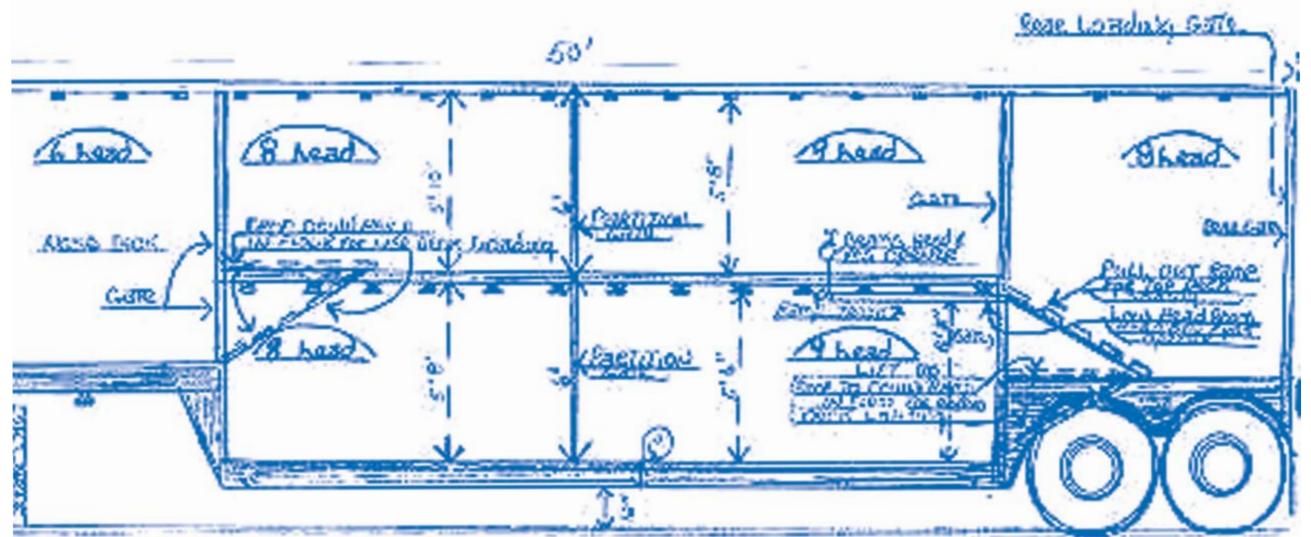
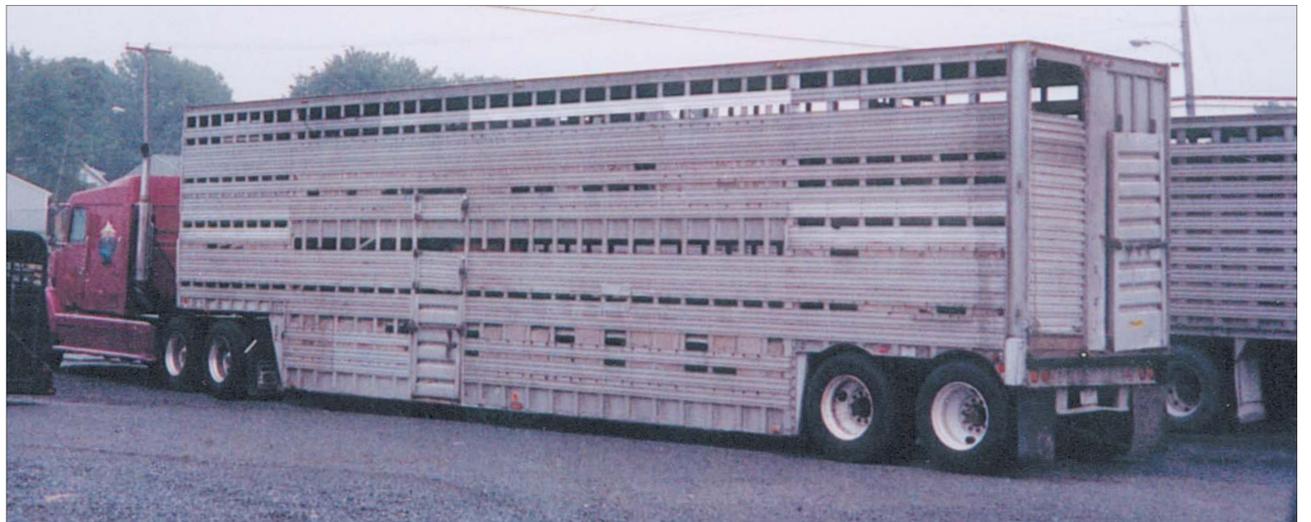
■ Above right: Double decker trailer owned by a New York "killer buyer" and used to transport horses for slaughter. The use of this double decker trailer resulted in convictions of over 50 counts in New York State of the New York State Agriculture and Markets Law, Section 359-a.

■ Bottom right: A double decker trailer used to transport horses. Horses are forced to lower their heads and jump down into the bottom deck. Horses have been loaded at night into this darkened trailer. Note the small entry way into the bottom deck and metal flooring.

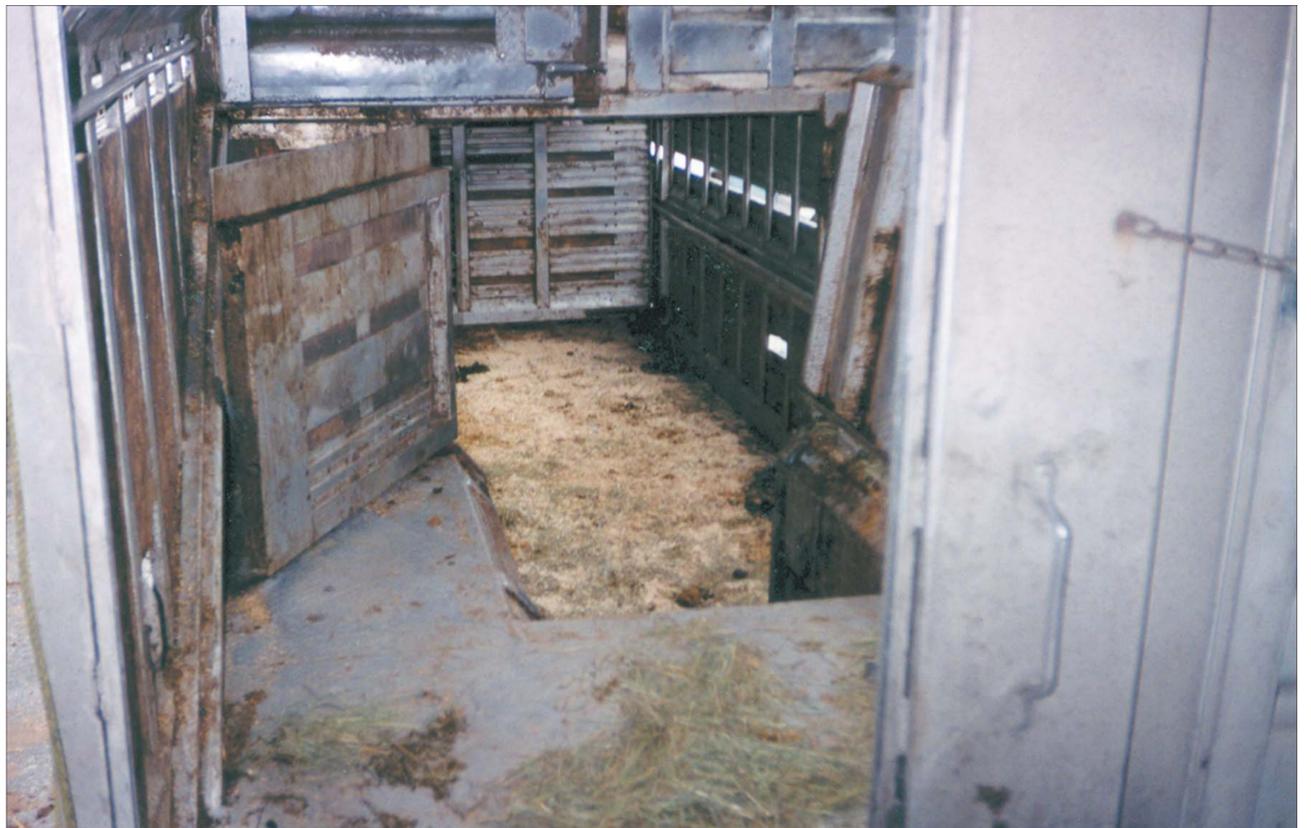
■ Horses on the bottom deck of a double trailer. Note the 3" I beams every 12" on center.

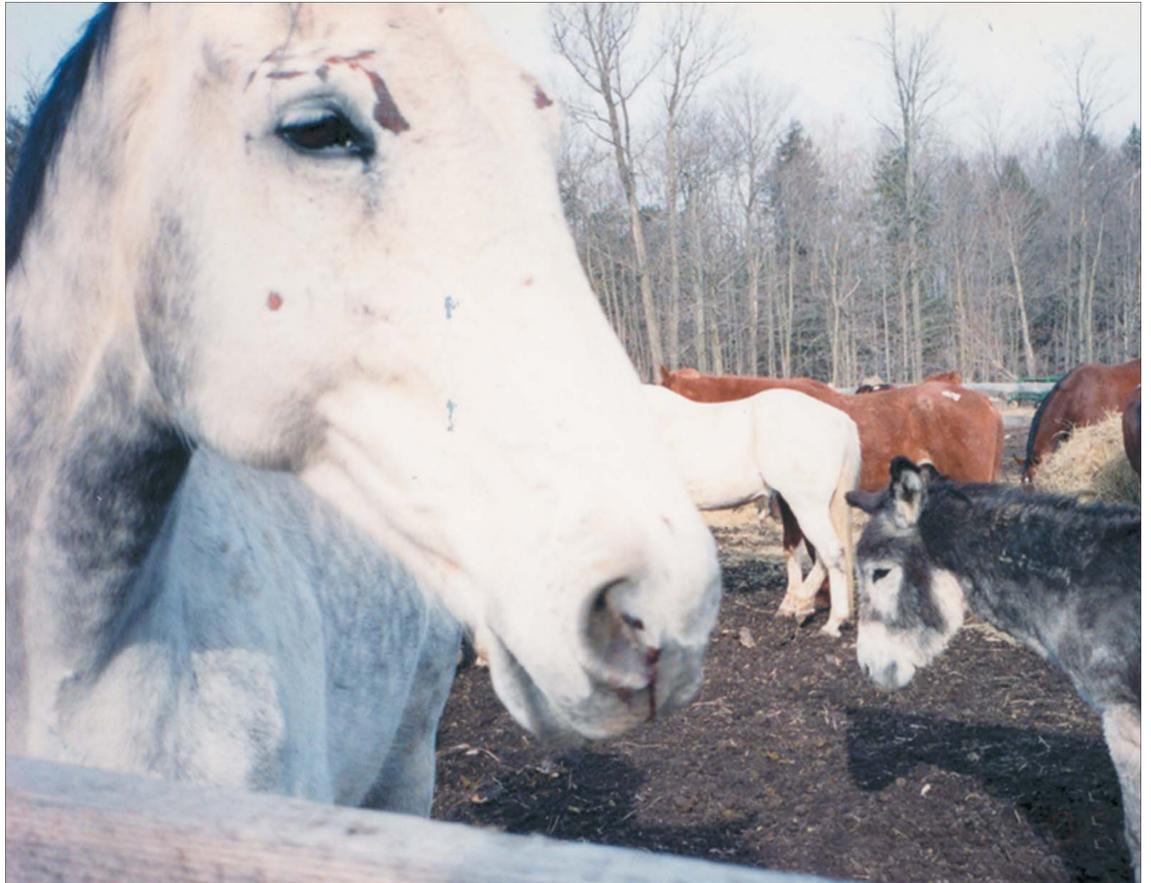
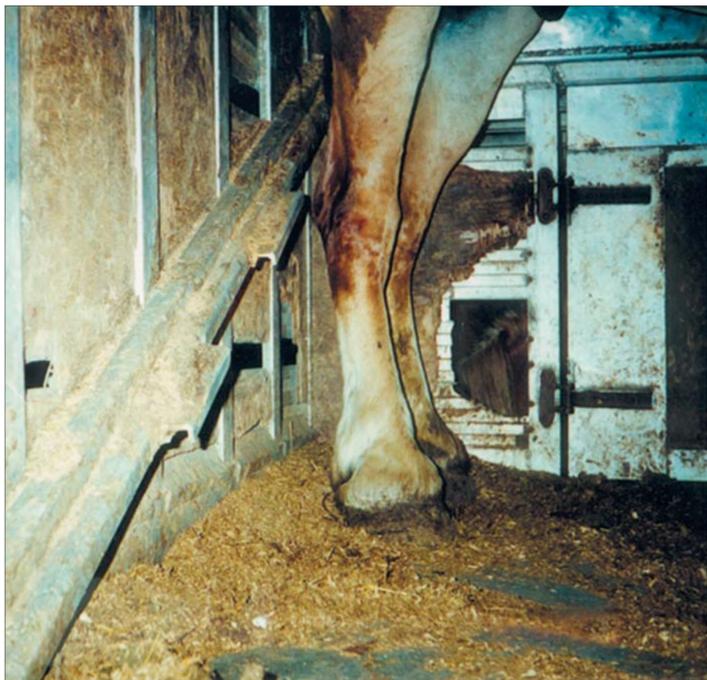
■ Above: Horses inside the “doghouse” area of a double decker. Note the exposed metal floor and the hole in the wall behind the horse’s leg, (horses are at risk for injury if they were to kick or paw and the leg would become caught in the opening.) Also note the slanted, sharp metal protrusion on wall behind horse’s leg, which supports the ramp to top deck when it is in the “down” position.

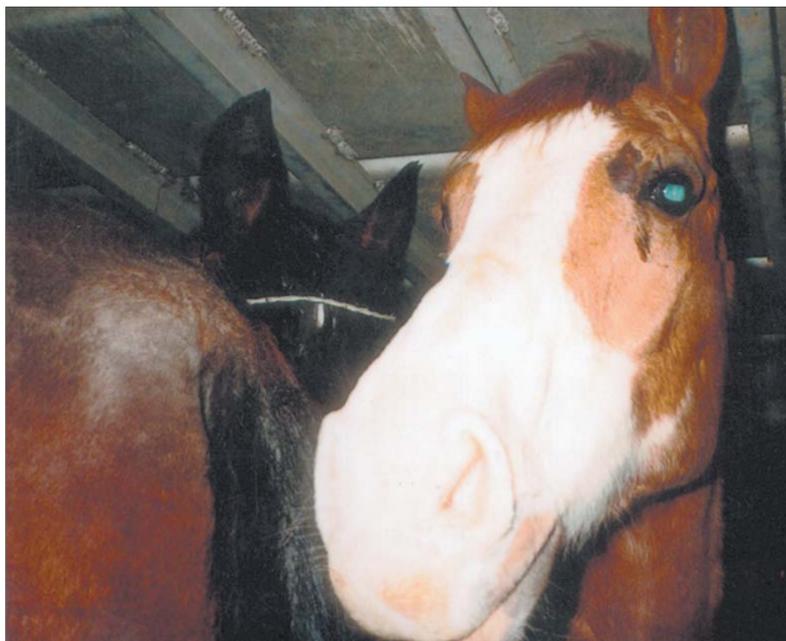
■ The bottom of a double deck trailer has 3” I beams every 12” on the center and metal floor. Lack of head clearance results in eye injuries as shown in photos above and left.

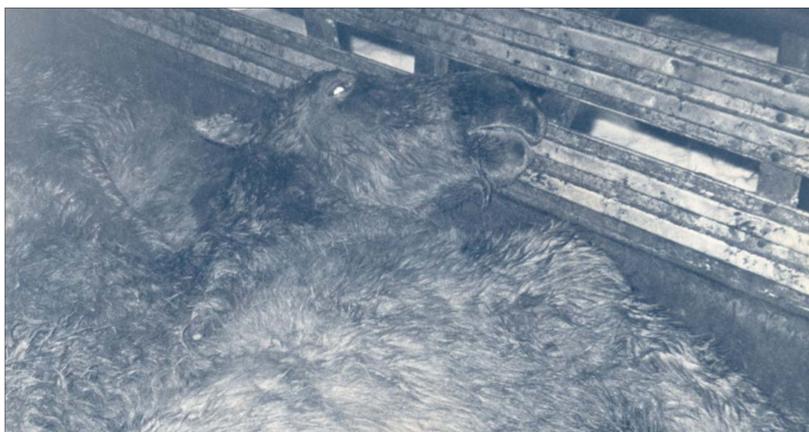
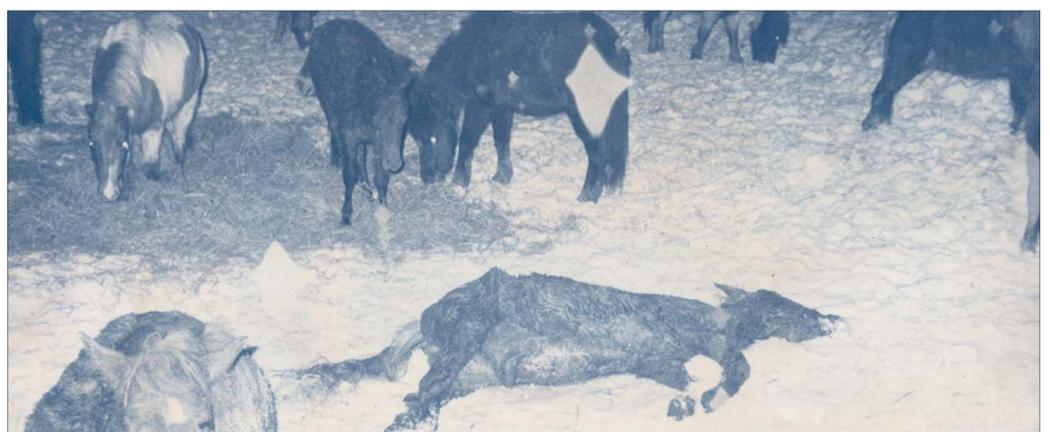
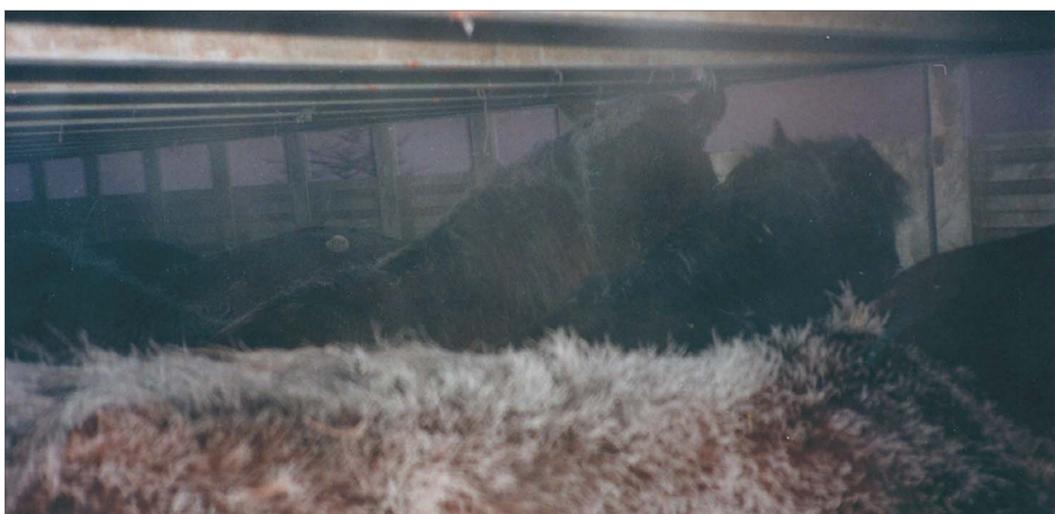
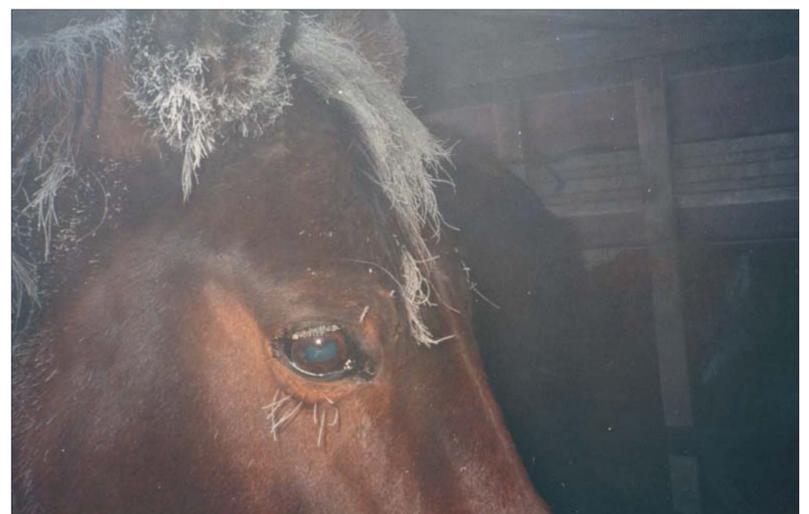
■ Photos on bottom show the pain and suffering these animals endure often ending in death as a result of this inhumane treatment.
