# Equine Protection Network

Diagram of 50' trailer designed to transport horses.

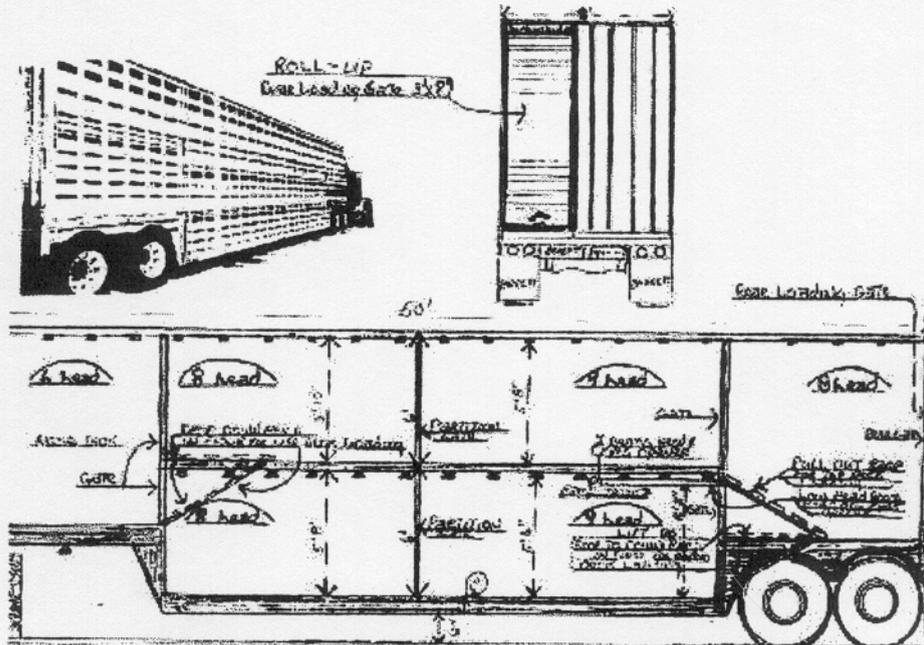
Figure 2

Diagram of 50' double deck trailer used to transport horses.

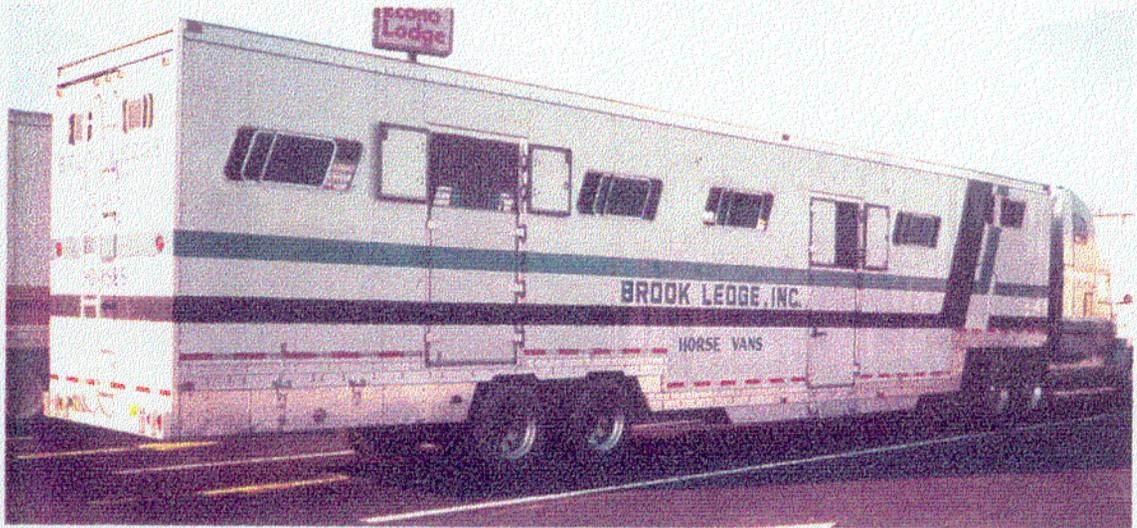
**Brook Ledge Horse Van designed and manufactured to transport horses.**

**Carries between 10 to 15 full size horses.**

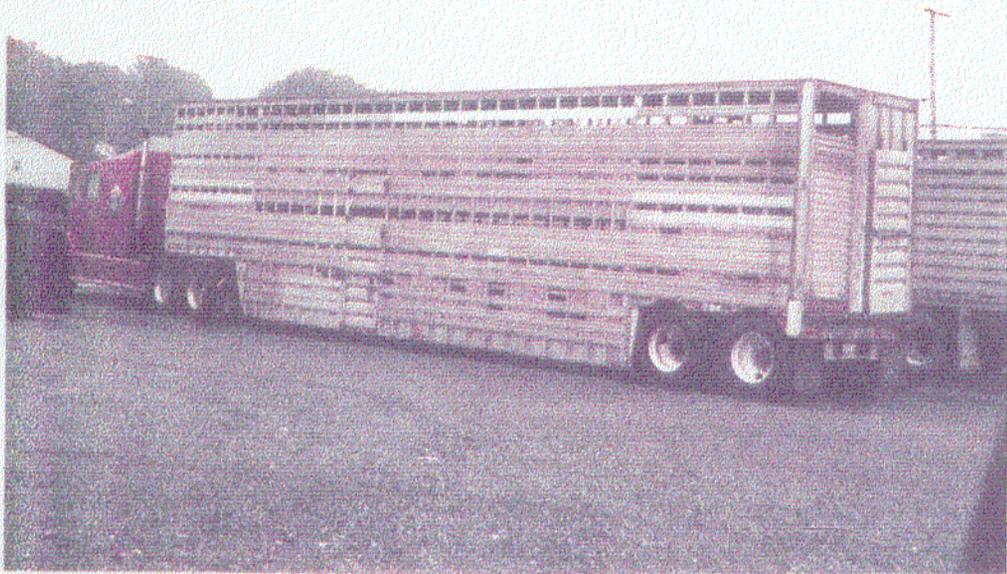
**Figure 4**

**Double deck trailer owned by a New York "killer buyer" and used to transport horses for slaughter.**

**The use of this double deck trailer resulted in convictions of over 50 counts in New York State of**

**the New York State Agriculture and Markets Law, Section 359-a.**

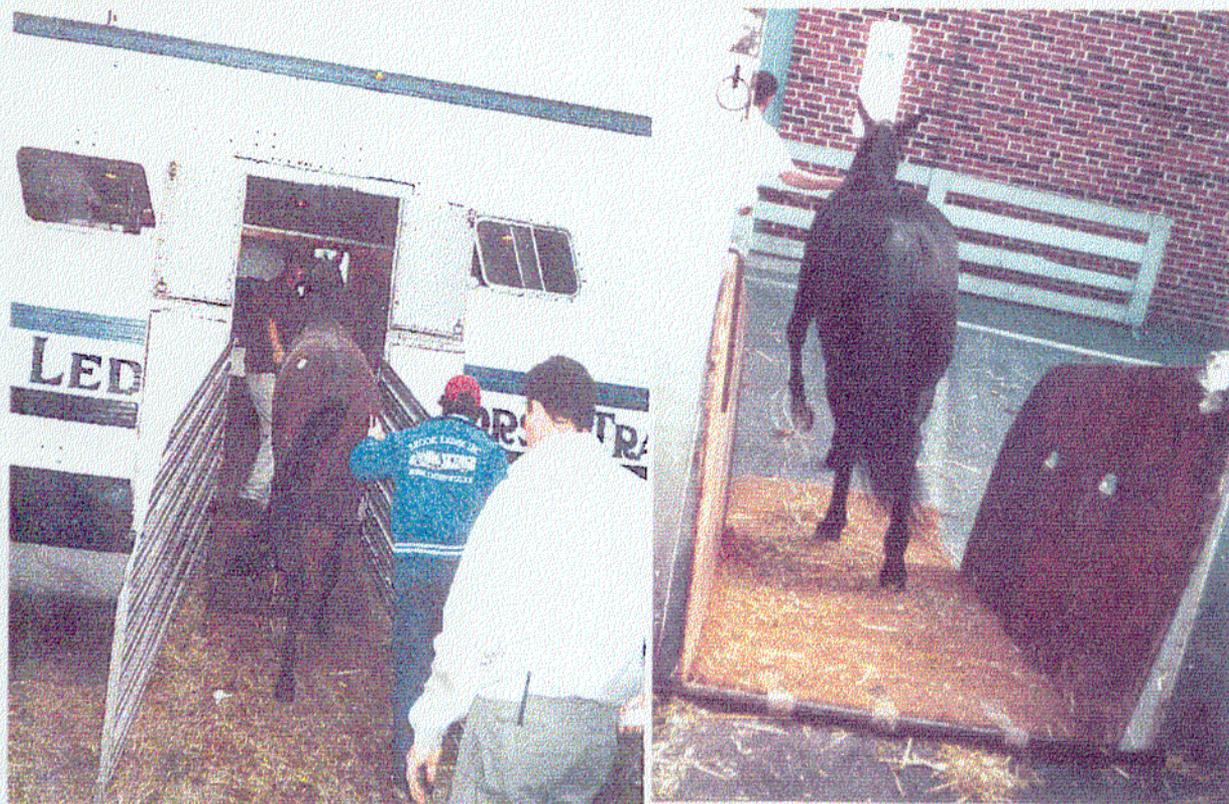
Standardbred horses are loaded and unloaded from a Brook Ledge Horse Van, Harrisburg, PA.

Loading ramp with side-boards. A cocoa mat ensures a secure, non-slip surface.

Note adequate door height and width and rubber non-skid surface inside trailer.

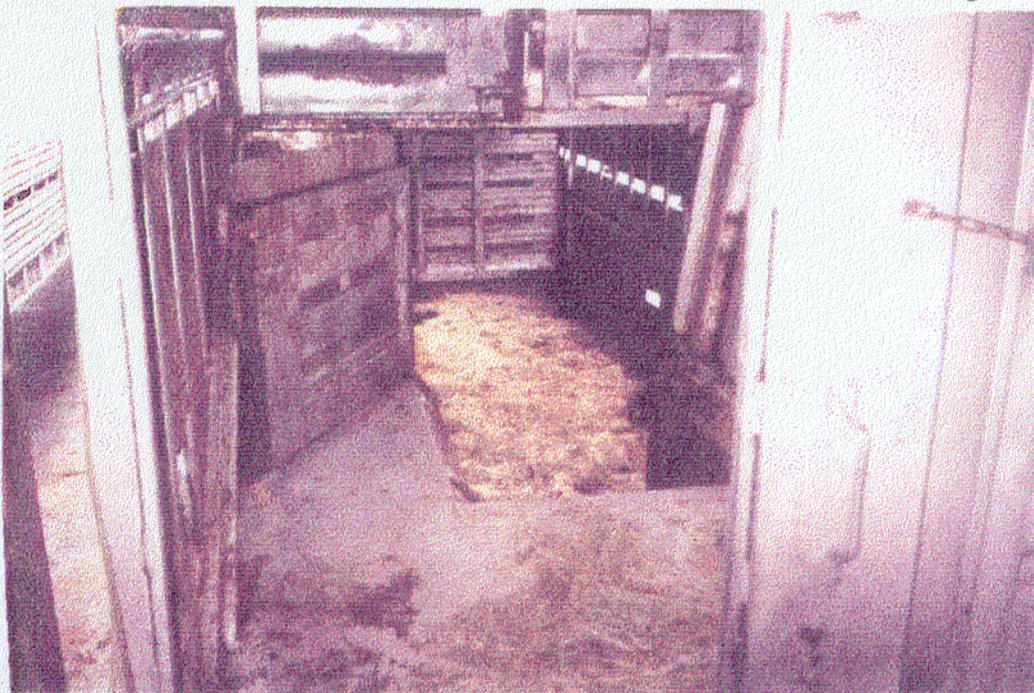
Figure 5

A double deck trailer used to transport horses. Horses are forced to lower their heads and jump down into the bottom deck. Horses have been loaded at night into this darkened trailer.

Note the small entryway into the bottom deck and metal flooring.

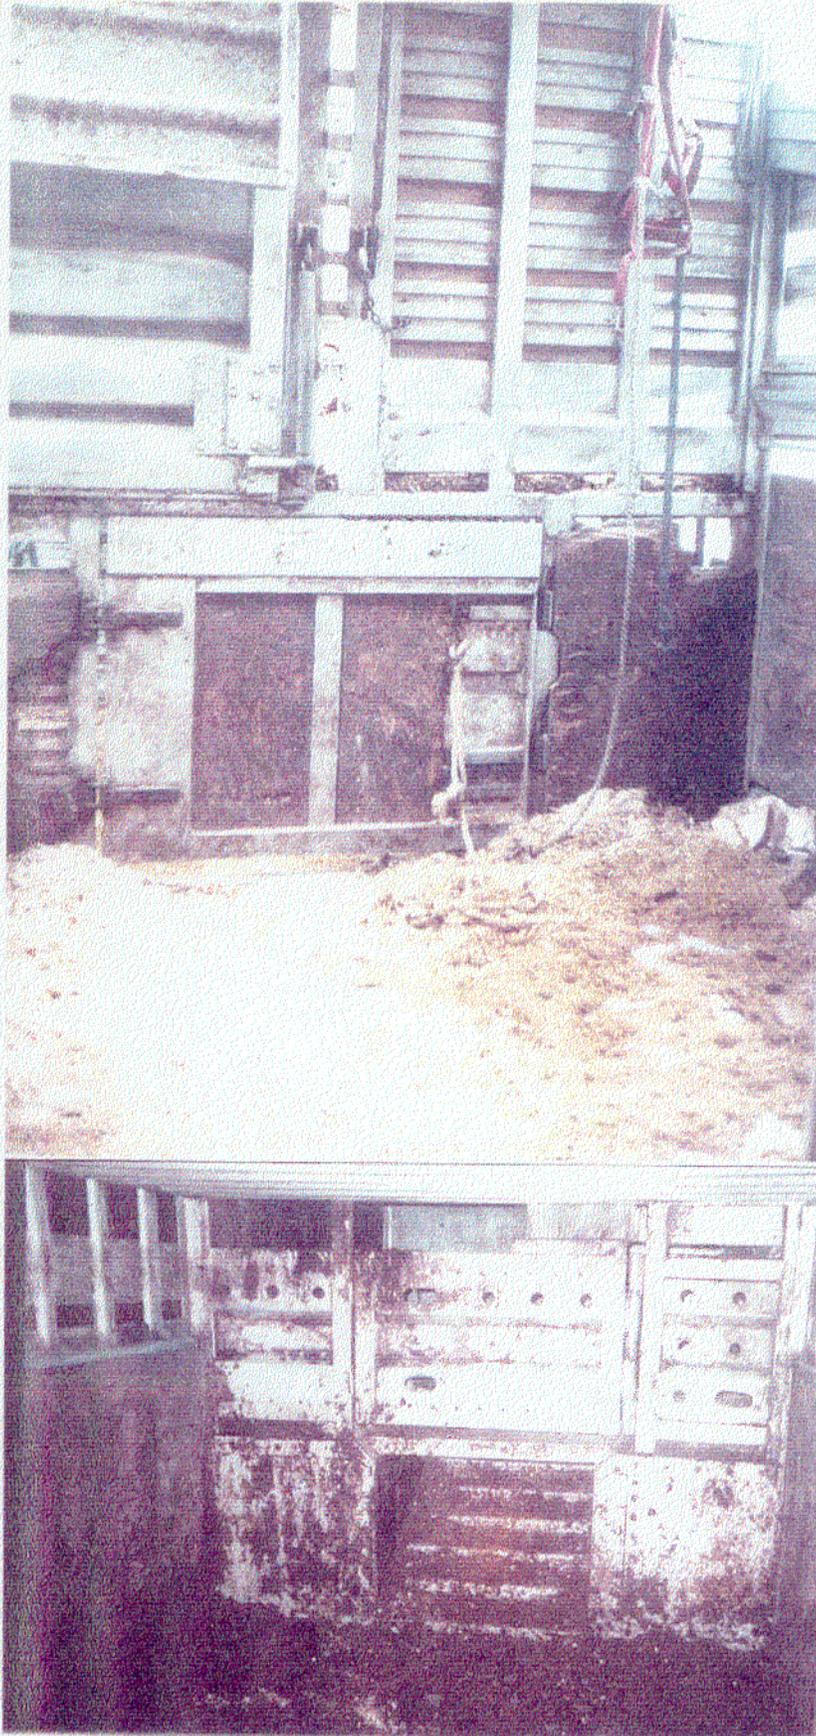
Figure 6

"Doghouse" area of trailer. Ramp to top deck is on the left. Door in middle adjacent to floor opens to bottom deck.

Example of the bottom deck of a double deck trailer. Ramp leads up to the "doghouse" area of trailer.

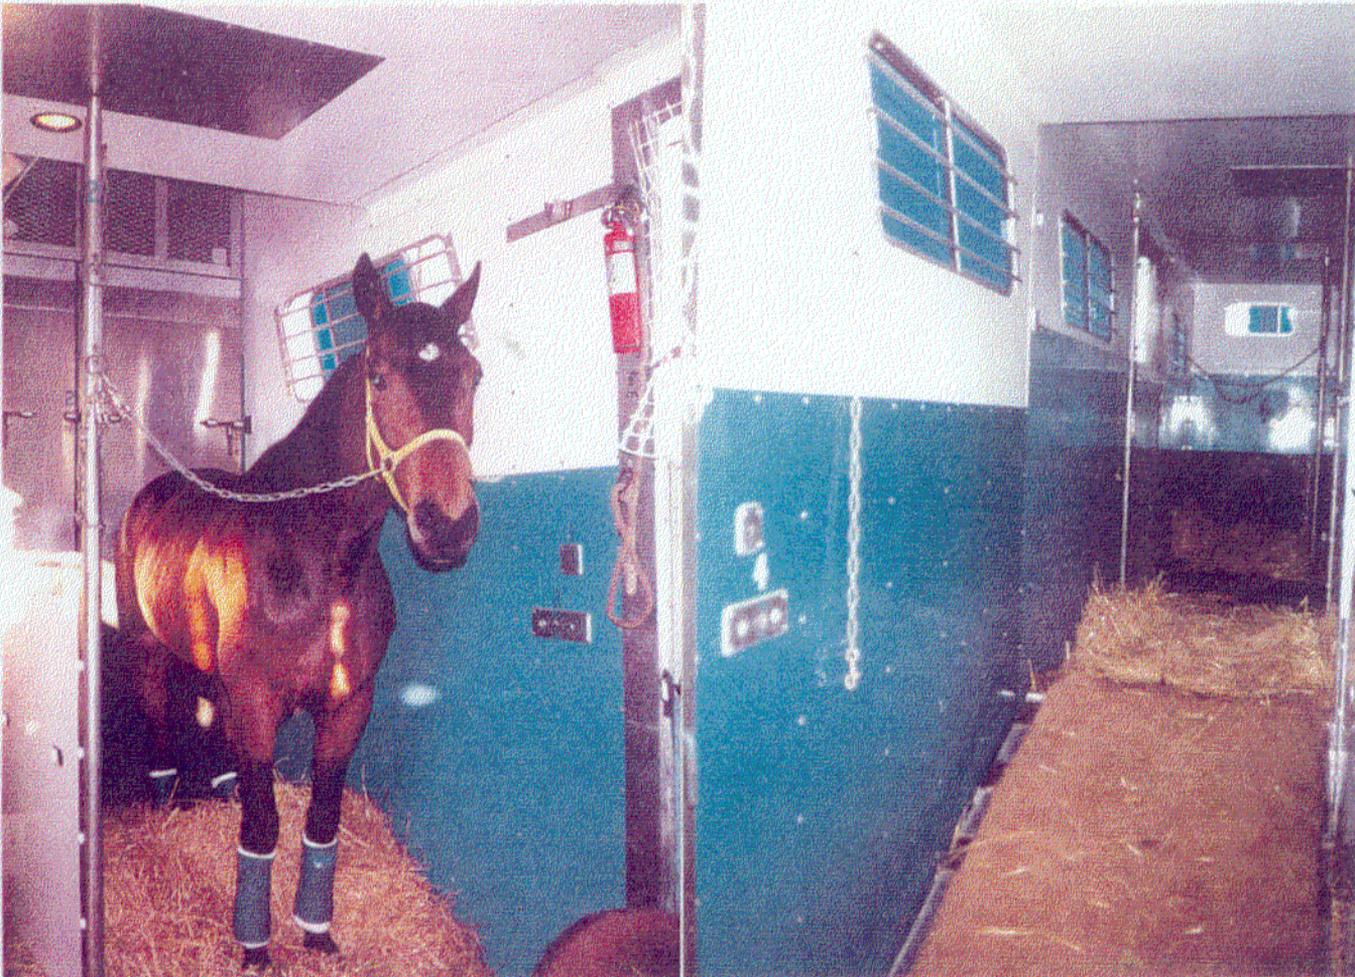
## Interior of Brook Ledge Horse Van.

Designed and manufactured to transport horses.

Interior height of 8'. Note amount of head clearance provided for the horse.

Note angle of the ramps. Ramps are covered with cocoa mats to provide secure footing.

Note the smooth walls and ceilings. Note clean bedding.

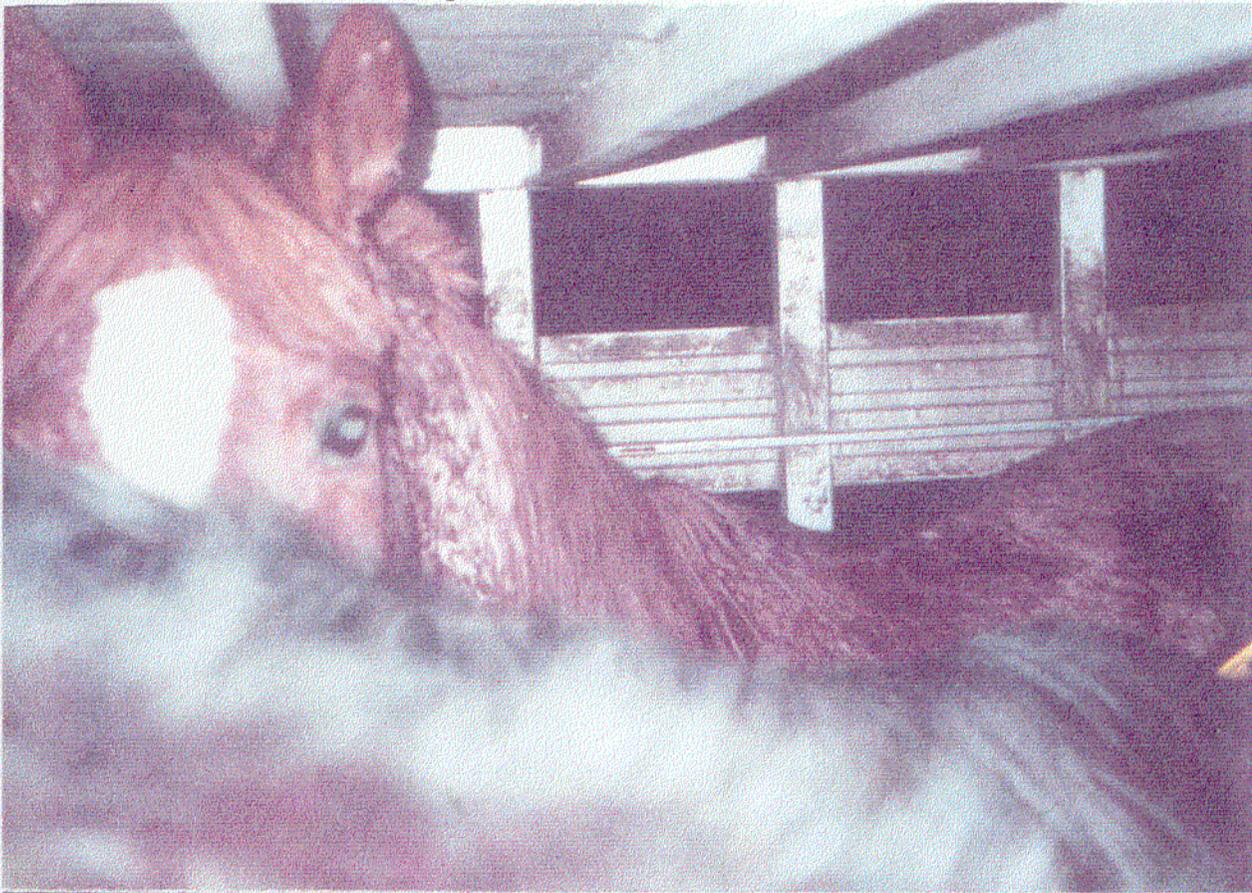
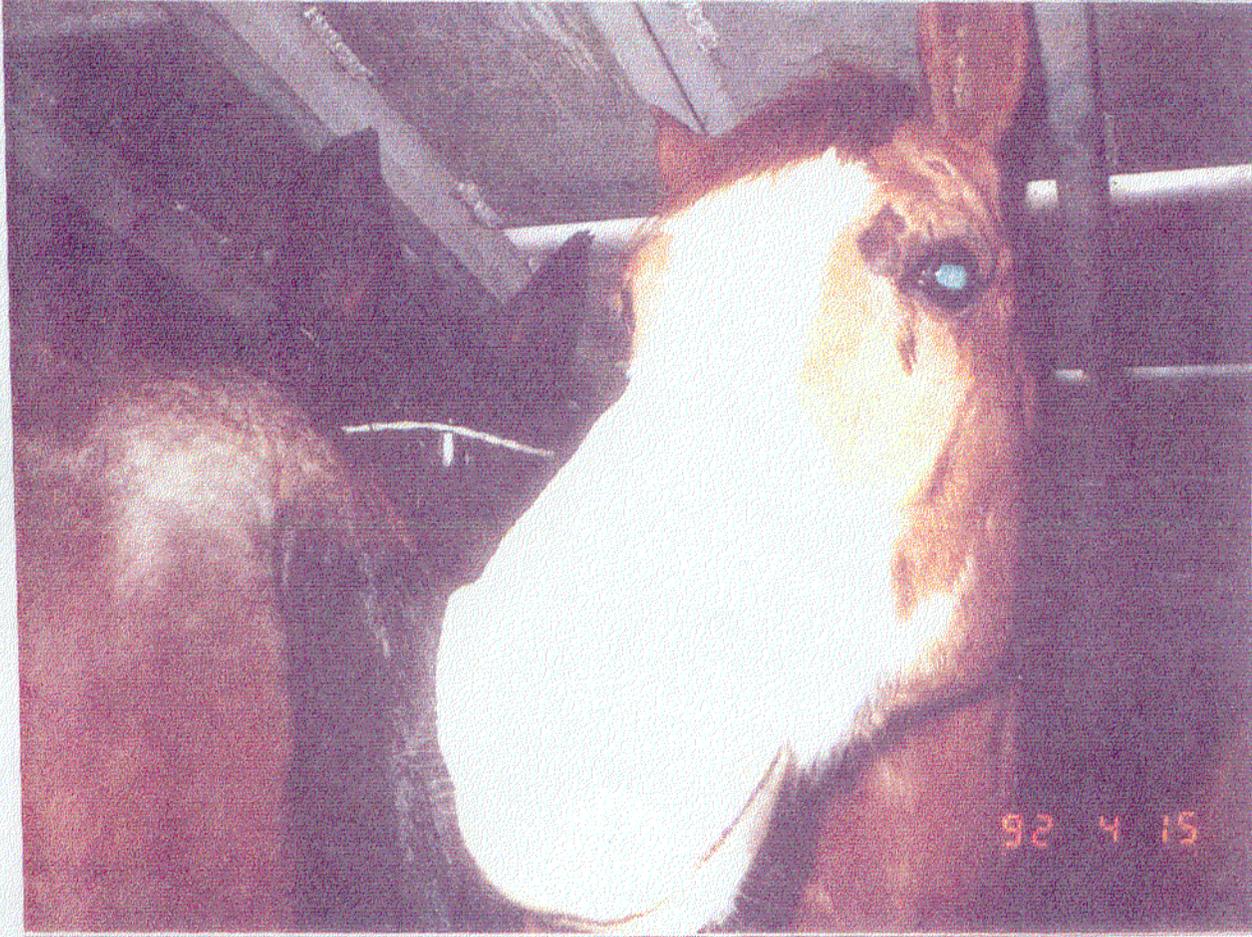
Figure 8

The next pictures depict horses inside double deck cattle trailers.

Note the horses' heads are against the ceiling.

The horse in the bottom photo has obvious facial injuries.

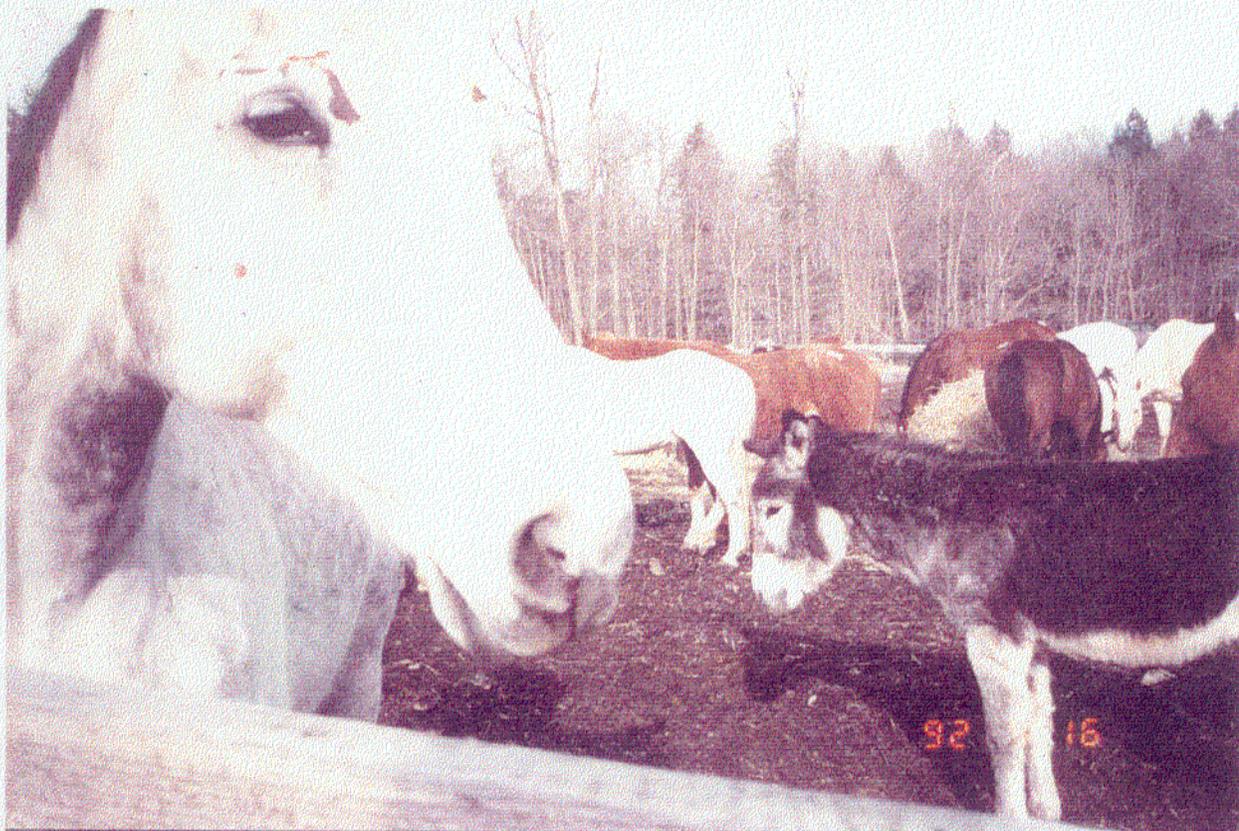
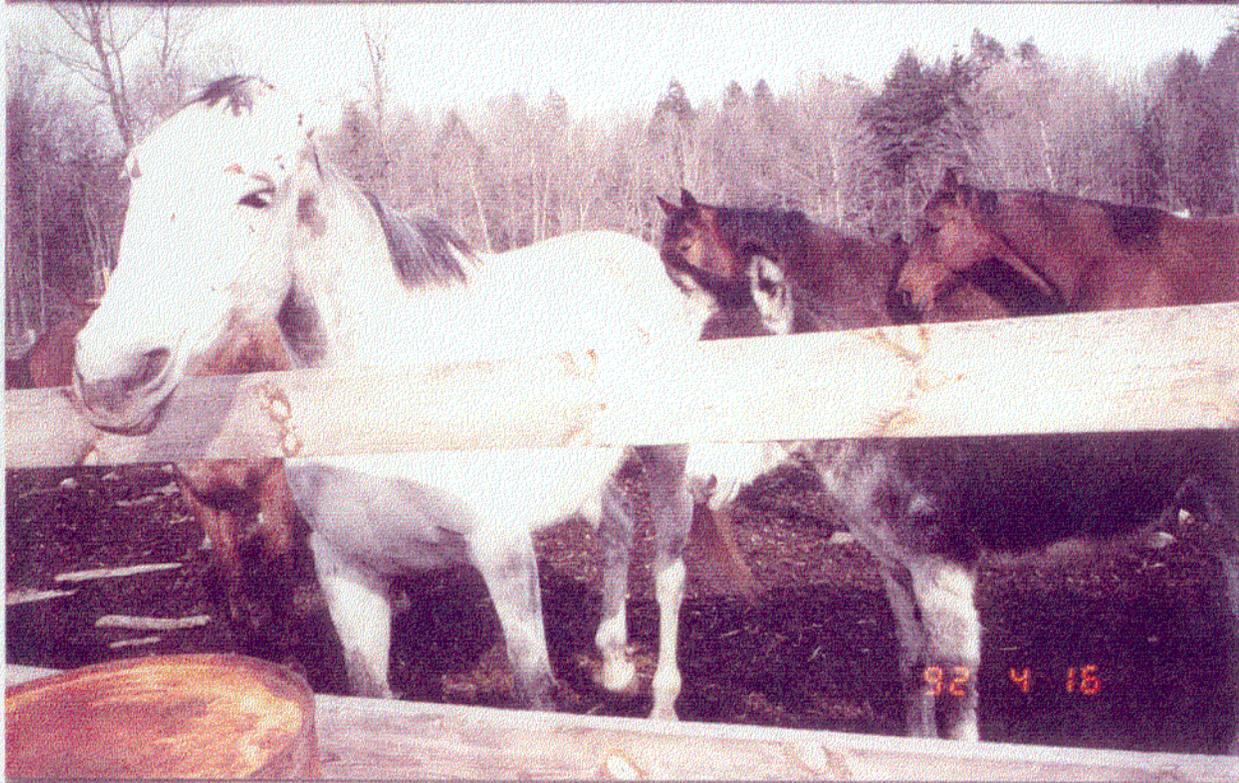
**Figure 9**

Horses removed from a double deck trailer.

Note the facial injuries on the gray horse, including bleeding from the right nostril.

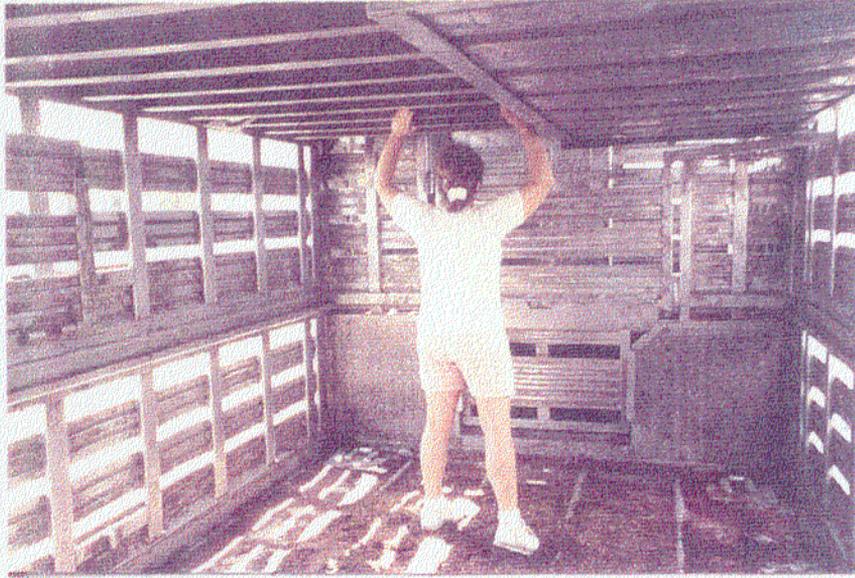
Bottom deck of a double deck trailer used to transport horses. The woman pictured is 5'2". Note the 3" I beams every 12" on center and the metal floor.

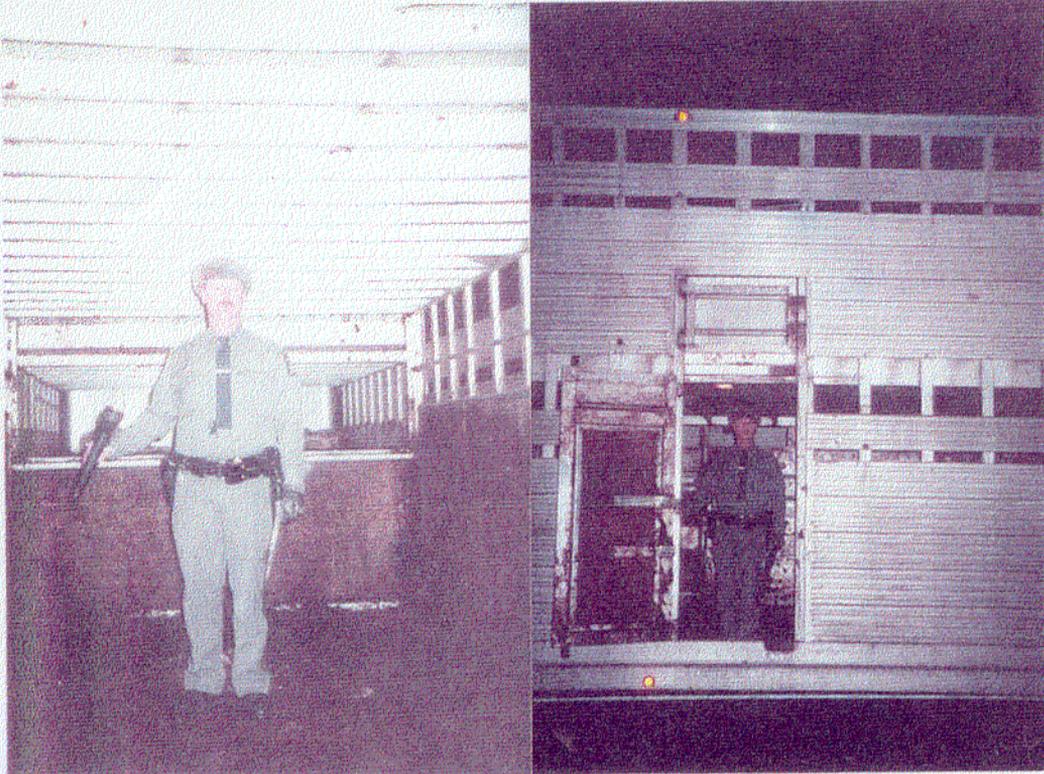
Figure 10

NY State Police trooper on the bottom deck of a double deck trailer. Trooper is less than 6' tall. Note the filthy conditions on the floor. Horses were on trailer less than 4 hours from the time they were loaded until they were unloaded. Note height & width of doorway.

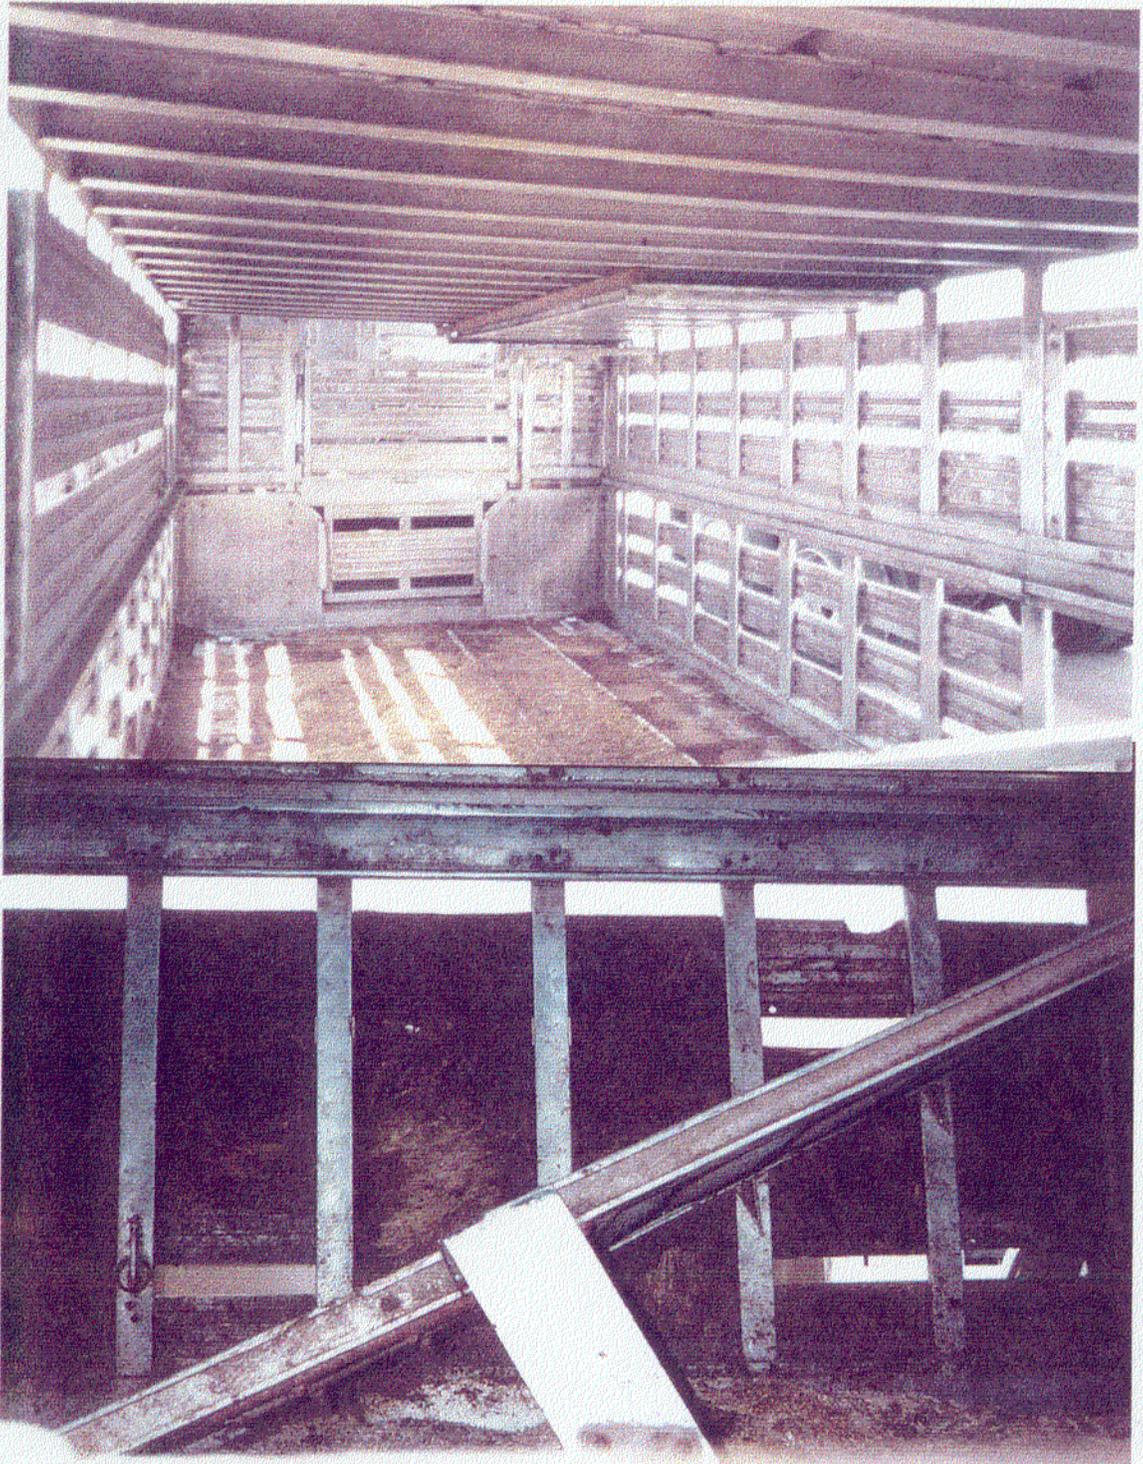
Figure 11

Interior view of bottom deck of a double deck trailer used to transport horses. Besides the 3" I beams protruding below the ceiling, there is a ramp that is stored on the ceiling.

Ramp located in the "doghouse" area of a double deck trailer used to transport horses. Ramp is used to load horses onto the top deck. Note the lack of sideboards to prevent horses from falling or slipping off the ramp. The ramp is metal with no rubber or cocoa matting.

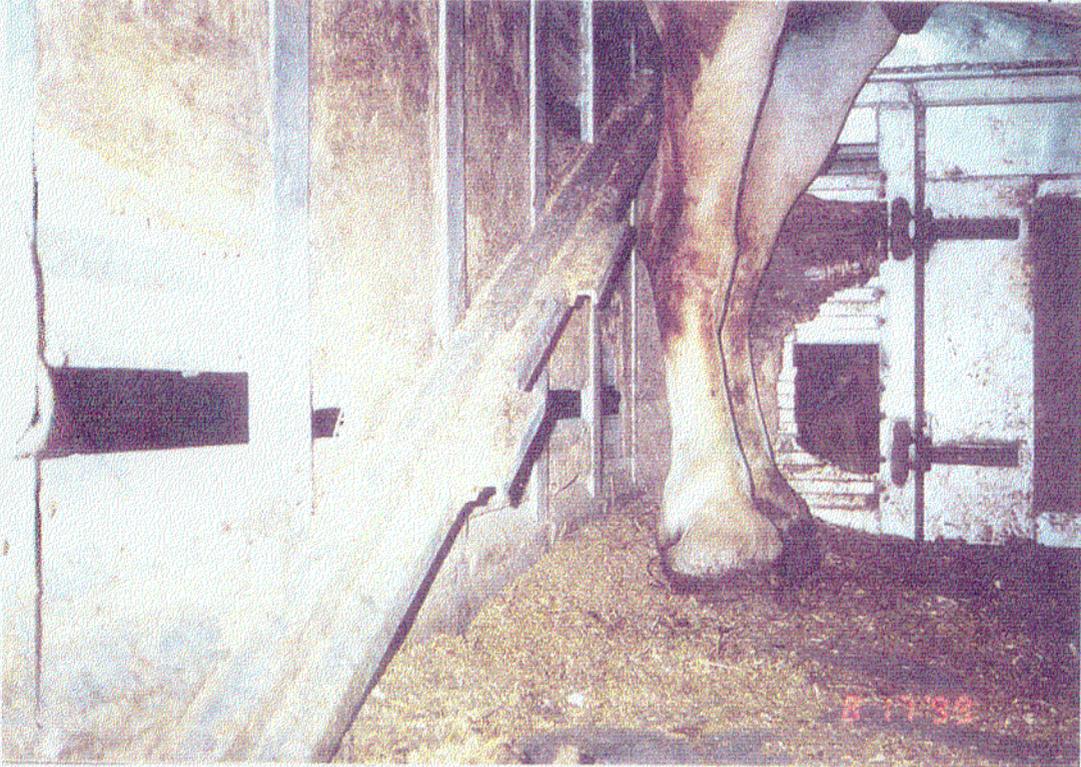
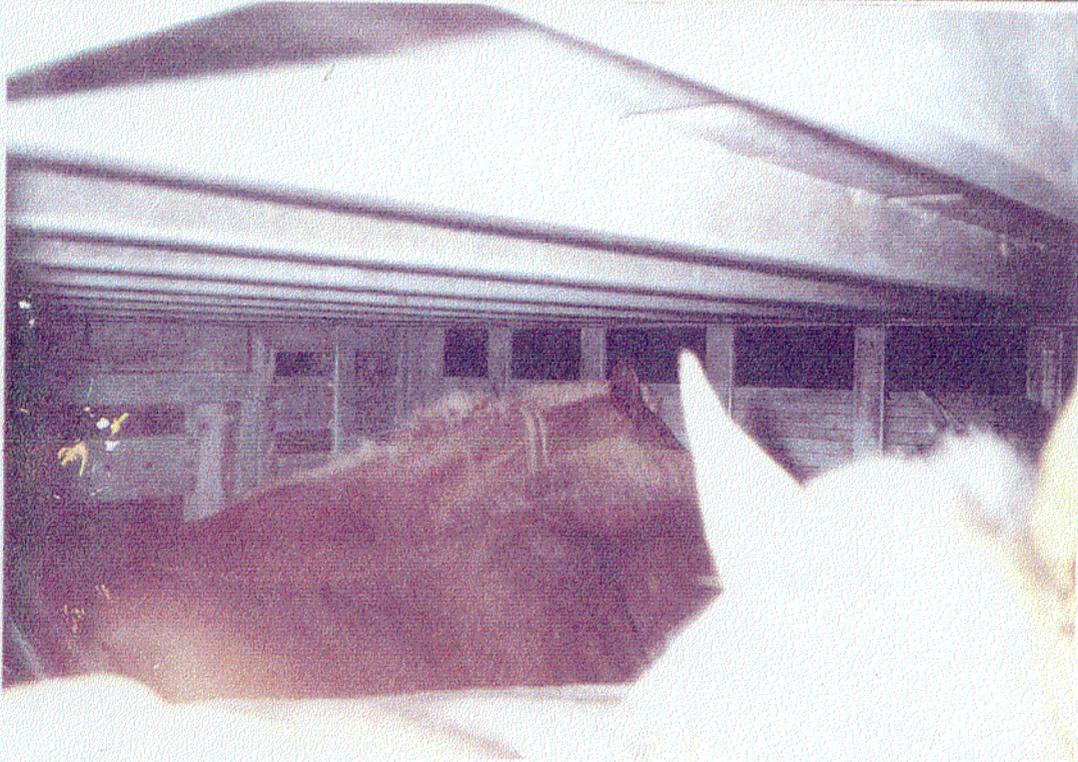
Figure 12

Horses inside the “doghouse” area of a double decker. Note the exposed metal floor and the hole in the wall behind the horse’s leg, (horses are at risk for injury if they were to kick or paw and the leg would become caught in the opening.) Note the slanted, sharp metal protrusion on wall behind horse’s leg, which supports the ramp to top deck when it is the “down” position.

Horses on the bottom deck of a double deck trailer. Note the 3" I beams every 12" on center.

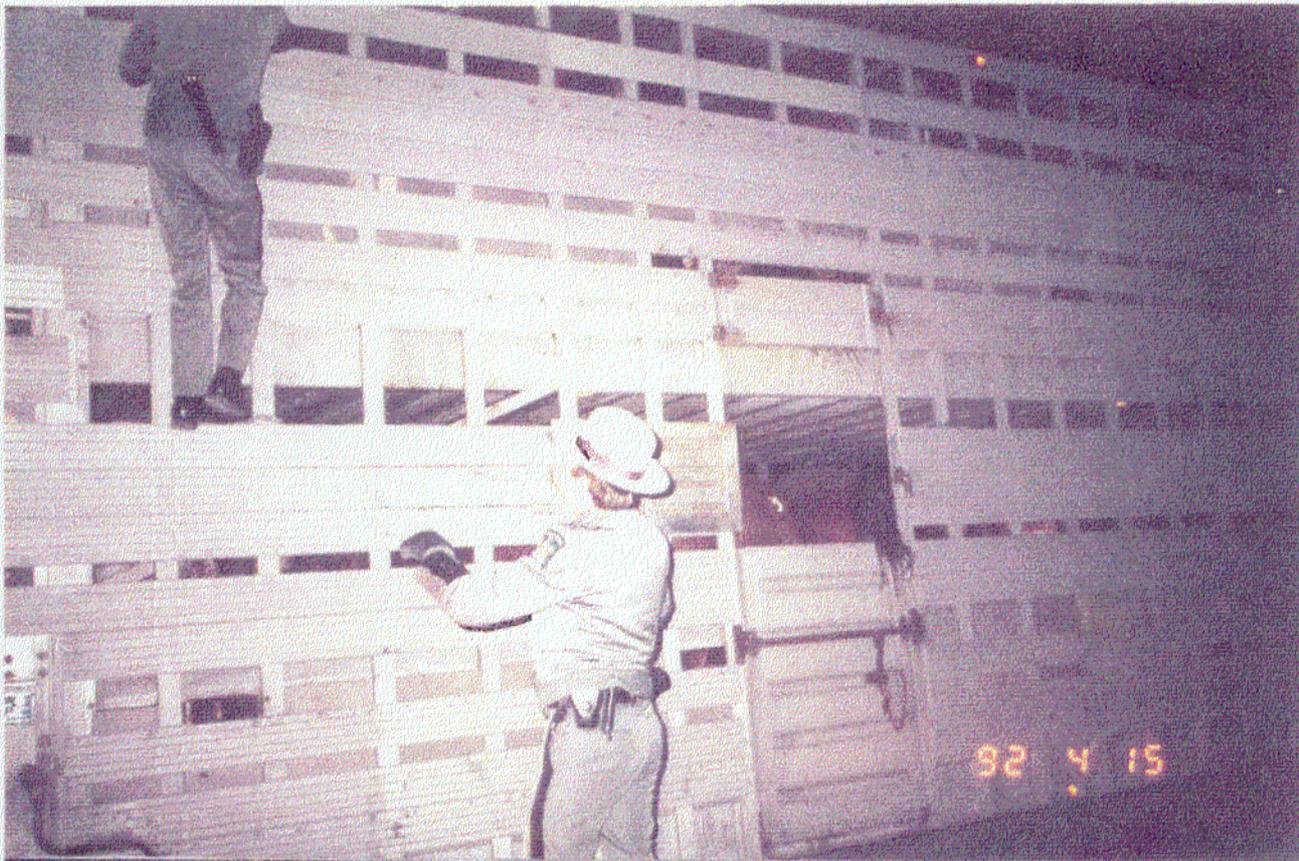
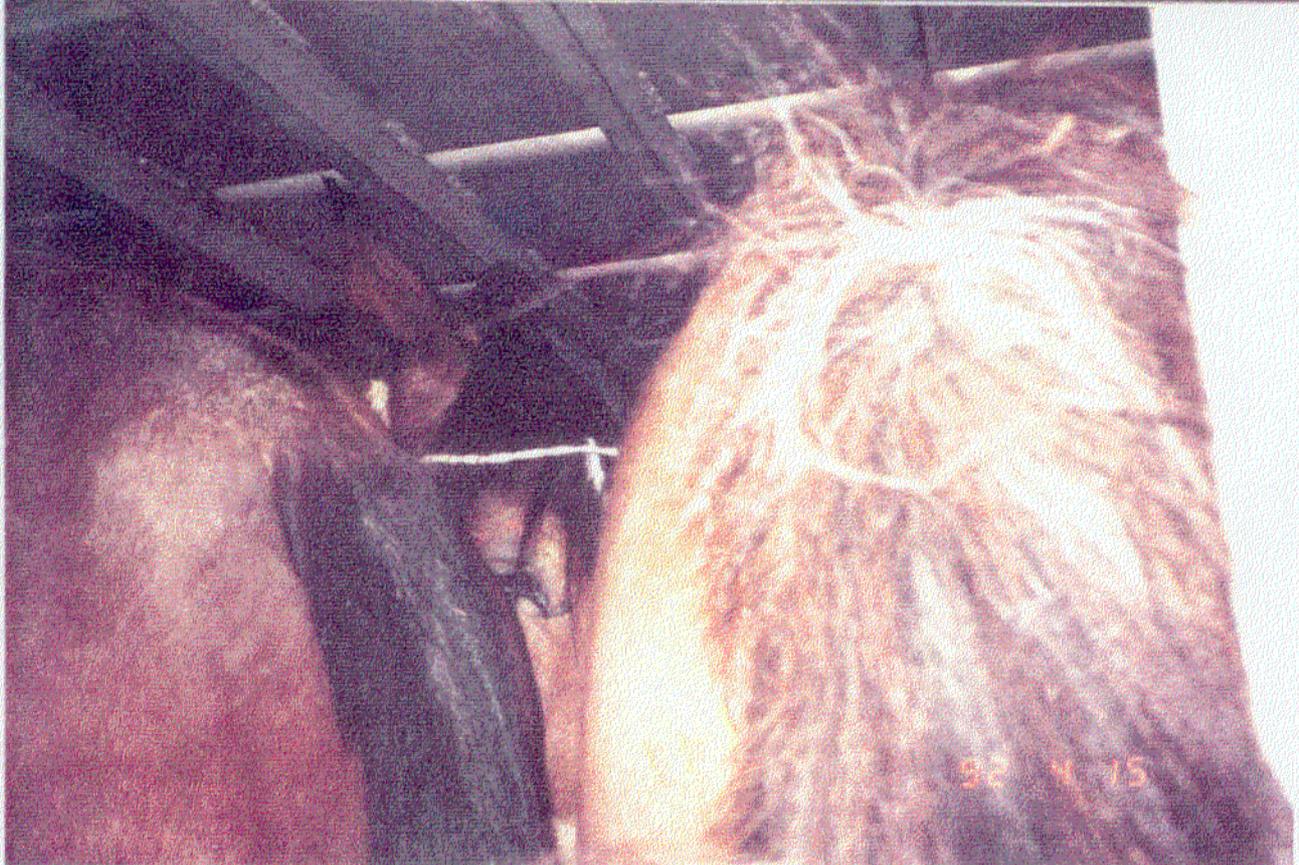
Figure 13

Note lack of head clearance resulting in an eye injury on the bay draft horse.
