## **Investigation of slaughter horse transport from Colorado to Illinois – External Report**

### **Transport of slaughter horses from Charles Carter feedlot in Longmont, CO to Cavel slaughter plant in DeKalb, IL.**

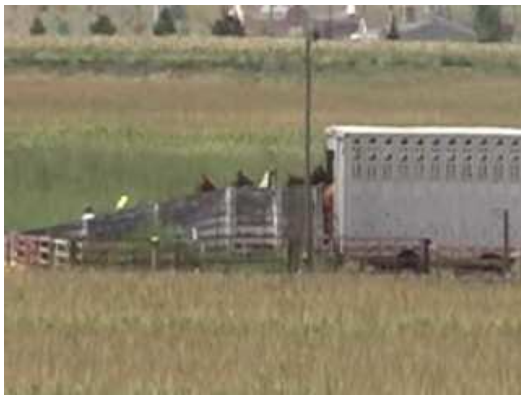
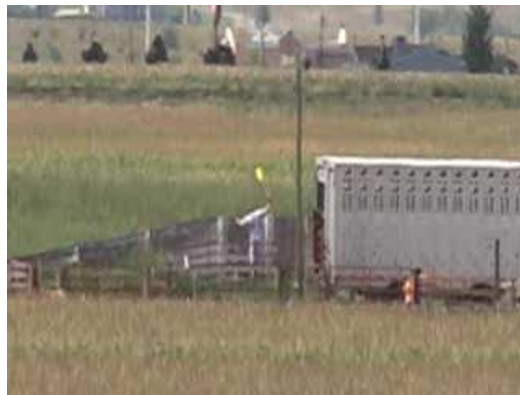
We arrived at Charles Carters feedlot at 12.30 pm. His maroon colored truck was backed up to the gate of the pen area in the back of the property. There were approx. 50 horses in the back pens and another 40 in the pens closer to the front of the property. In addition, there were several pick-up trucks with small horse trailers loading and unloading horses into the pen area. It appears that local farmers /small horse traders deliver directly to Mr. Carter's lot. In addition, several rescues have access to the property and buy horses from him.

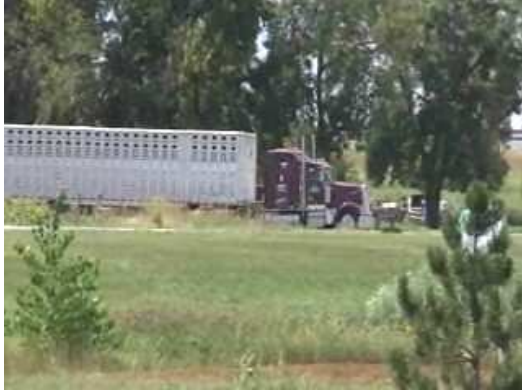
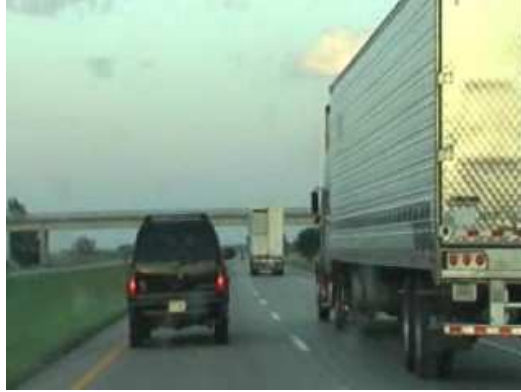
In the lower part of both sides of the trailer were slats installed, likely to prevent observation of the horses from the outside.

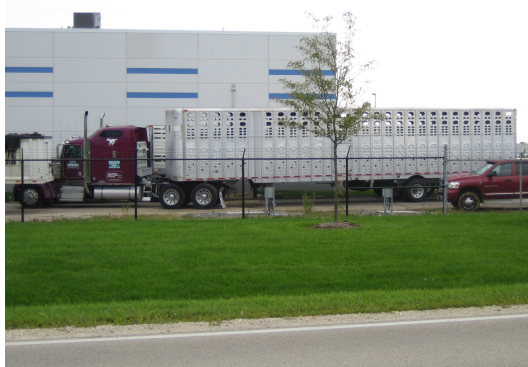
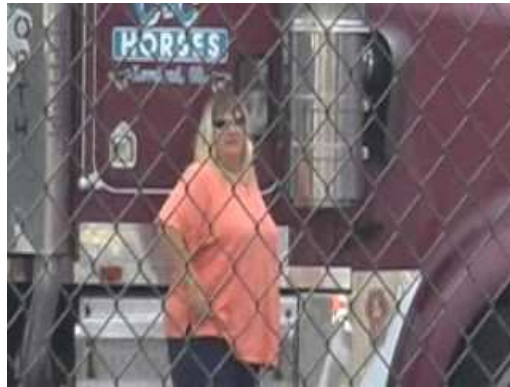
The Carter truck backed up to the loading dock at 8.40am and started unloading the horses shortly thereafter. The unloading was finished at 9.30am CT. He then left the loading ramp and parked. (11.10am CT) The truck left the Cavel premises at 11.22am CT and started heading back towards Colorado on Road 38 west. Around 12.15 pm the truck arrived at Rochelle rest station and the driver finally took a break to sleep. Six hours later he started driving again.
